Re: Stop 18 Reconnaissance Inspection July 8, 2013  
Field Screening at Calle Figueroa/Calle Villamil Storm Sewer Main  
Municipality of San Juan ("MSJ") Municipal Separate Storm Sewer System ("MS4") Permit  
(PRR040036)  
PRASA Puerto Nuevo Wastewater Treatment Plant Collection System (PR0021555)  
Puerto Rico Department of Transportation and Public Works (DTOP) MS4 Permit (PRR040080)

**Reconnaissance  
Inspection:** Department of Natural and Environmental Resources (DNER) Barriada  
Figueroa (Stop 18 Pump Station) collection system

**Inspection Date:** July 8, 2013

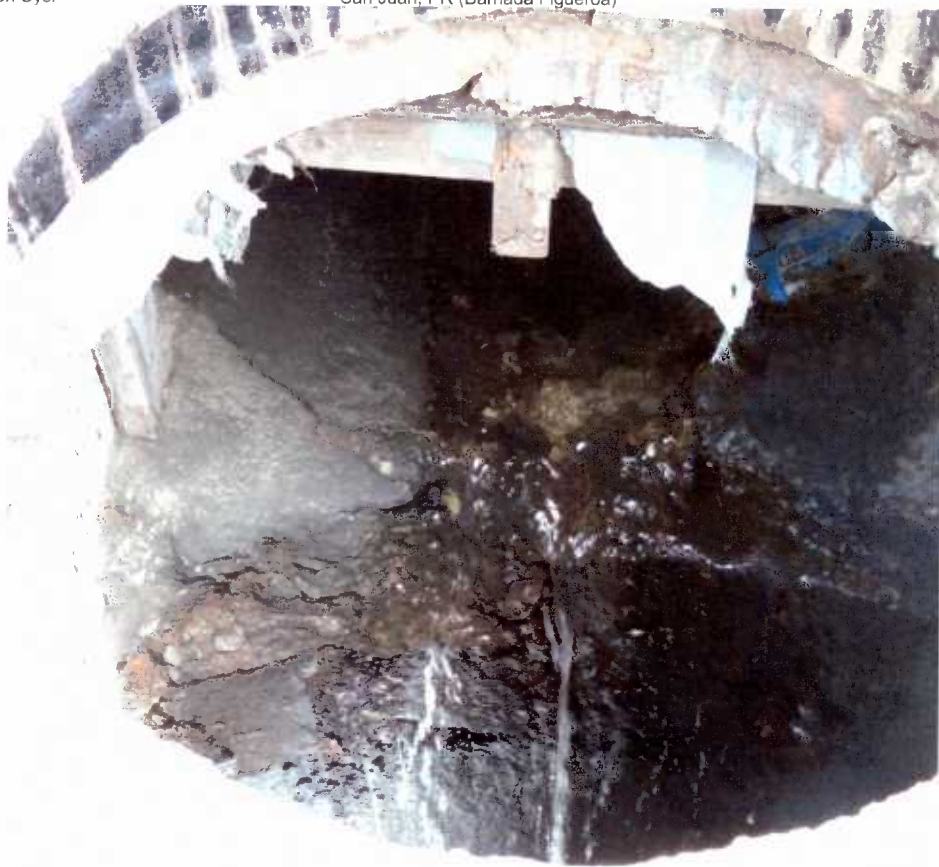
### **1. Calle Figueroa and Calle Corchado – Photos DSCN1354 (1354) to 1357**

- a. EPA opened the manhole on the western side of Calle Figueroa at the North Side of Calle Corchado and observed a large (what appeared to be a box sewer) with a large volume of standing water. A grab sample was taken and using ammonia test strips the ammonia level was 1 mg/l.
- b. As shown in photograph 1354 on the west side of Calle Figueroa on the South Side of Calle Corchado there was a flow entering the large storm sewer shown in photos 1355 to 1357. Ammonia concentrations of this flow entering the large storm sewer was 0.5 mg/l.

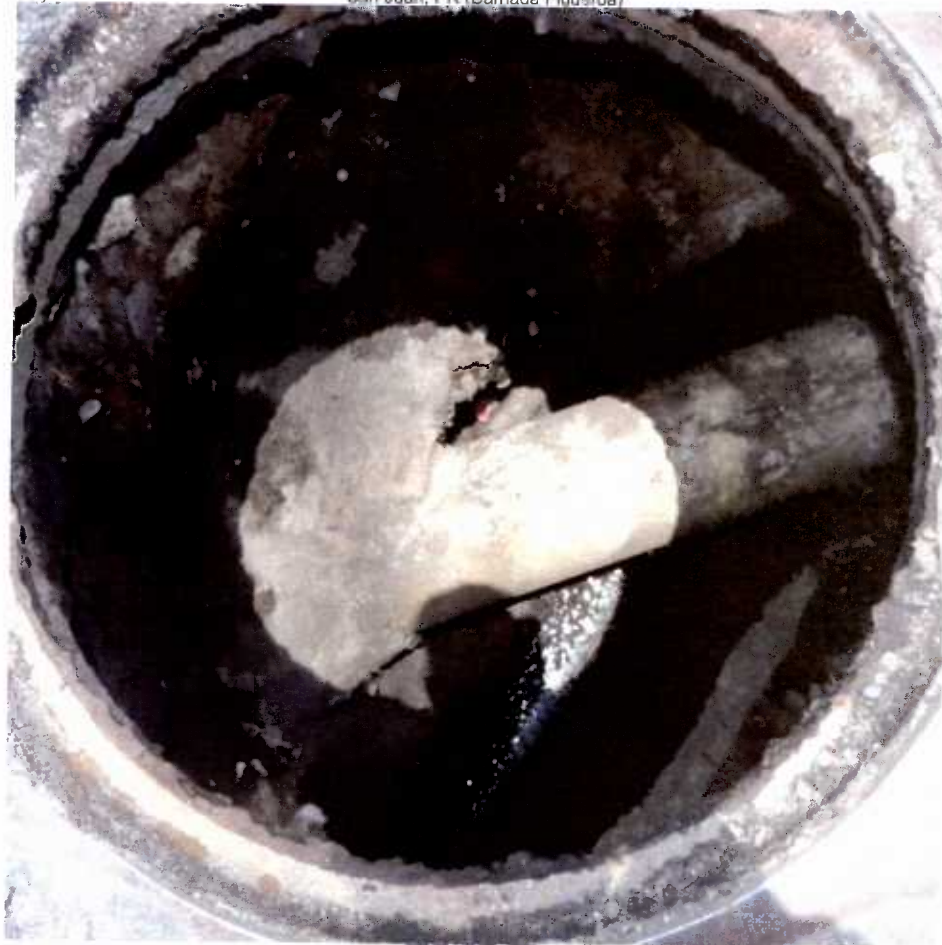
DSCN1362.JPG  
07/08/2013

DSCN1362	Manhole at Calle Villamil and Calle Progreso. There was a white closed pipe inside the manhole and also an apparent catch basin connection into the large storm sewer that flows to the DNER Stop 18 PS.
DSCN1363	Manhole at Calle Villamil and Calle Progreso. There was a white closed pipe inside the manhole and also an apparent catch basin connection into the large storm sewer that flows to the DNER Stop 18 PS.
DSCN1364	Large storm sewer manhole at Calle Villamil and Calle Progreso with a flow entering from the east.
DSCN1365	Large storm sewer manhole at Calle Villamil and Calle Progreso with a flow entering from the northwest
DSCN1366	Video of large storm sewer manhole with flows entering from the northwest and east at Calle Villamil and Calle Progreso
DSCN1367	Manhole Calle America and Calle Progreso
DSCN1368	Street sign at Calle America and Calle Progreso
DSCN1369	Large stormsewer manhole at Calle Las Flores and Calle Villamil

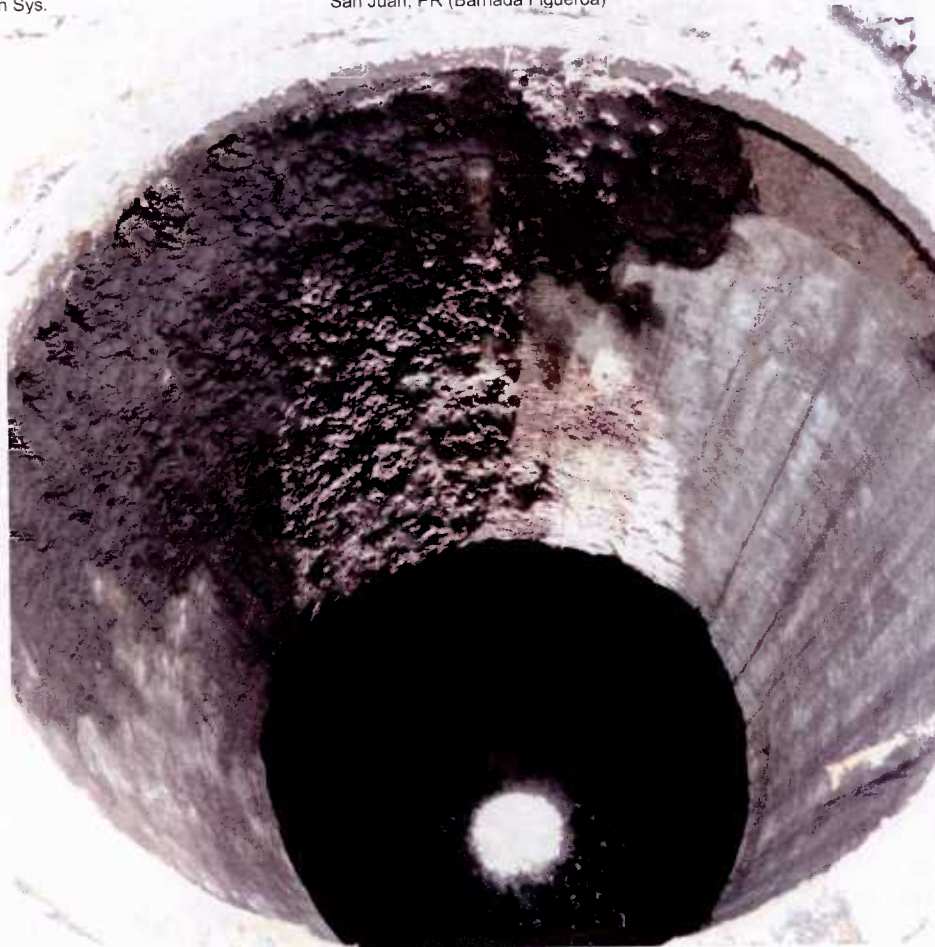
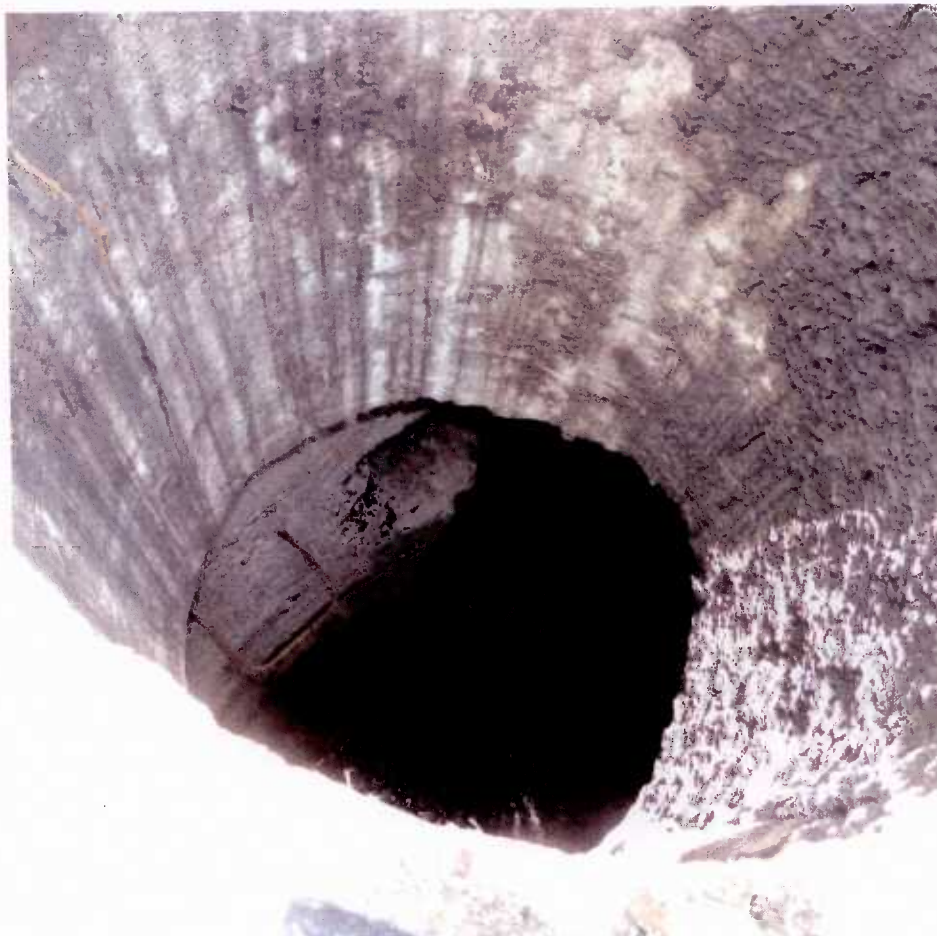
DSCN1364.JPG  
07/08/2013

The manhole for the large storm sewer on western side of street initially had large volume of standing water with ammonia levels of 1 mg/l but, apparently after the Stop 18 Pump Station activated, there was a considerable flow in the large storm sewer flowing

south towards the pump station Photos 1364, 1365 Video 1366. There were 2 other pipes that were visible and had dry weather flows into the large storm sewer. One pipe with a dry weather flow from the east (Photo 1364, Video 1366) had ammonia levels of 0.5 mg/l. Another pipe entering relatively high in the manhole (Photo 1365 and Video 1366) from the northwest had ammonia levels of approximately 1 mg/l. After the apparent activation of the Stop 18 pump station another sample was taken in the large storm sewer main and there was an ammonia concentration of 3 mg/l. It is possible that other pipes enter into this manhole, however, it appears that the base of the manhole is larger than the upper portions of the manhole, and the inspectors were unable to see beneath this ledge or rim.

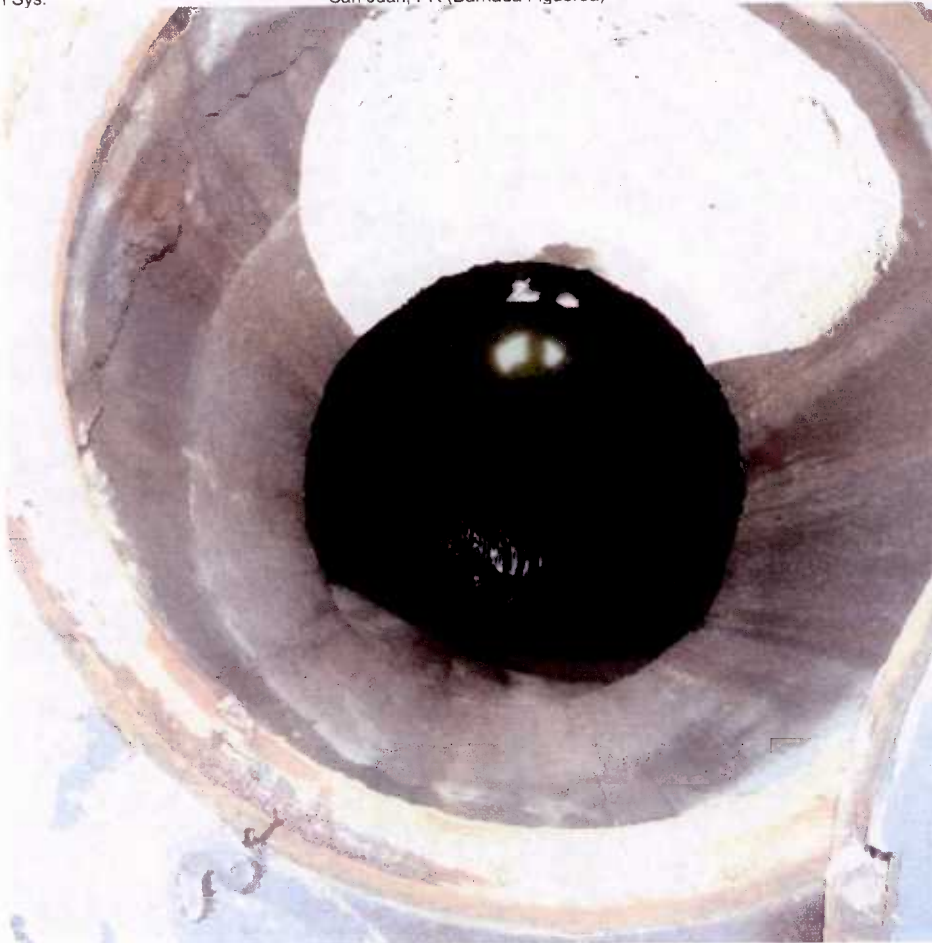
DSCN1369.JPG  
07/08/2013

As shown in photograph 1369 there is a deep manhole for the large storm sewer that flows south from Calle Las Flores to the DNER Stop 18 Pump Station. Ammonia levels taken from the storm sewer at this location had ammonia levels of 1 to 3 mg/l.

In August 2008 EPA's Contractor, SAIC, collected a sample at this same location and the results are contained in 2008 of the March 2009 inspection report. The SAIC inspection verified via dye testing that this same storm sewer at Calle Las Flores and Calle Villamil flows into the Stop 18 Pump Station and also verified that there was sewage in this large storm sewer that enters the Stop 18 PS as shown in the table below.

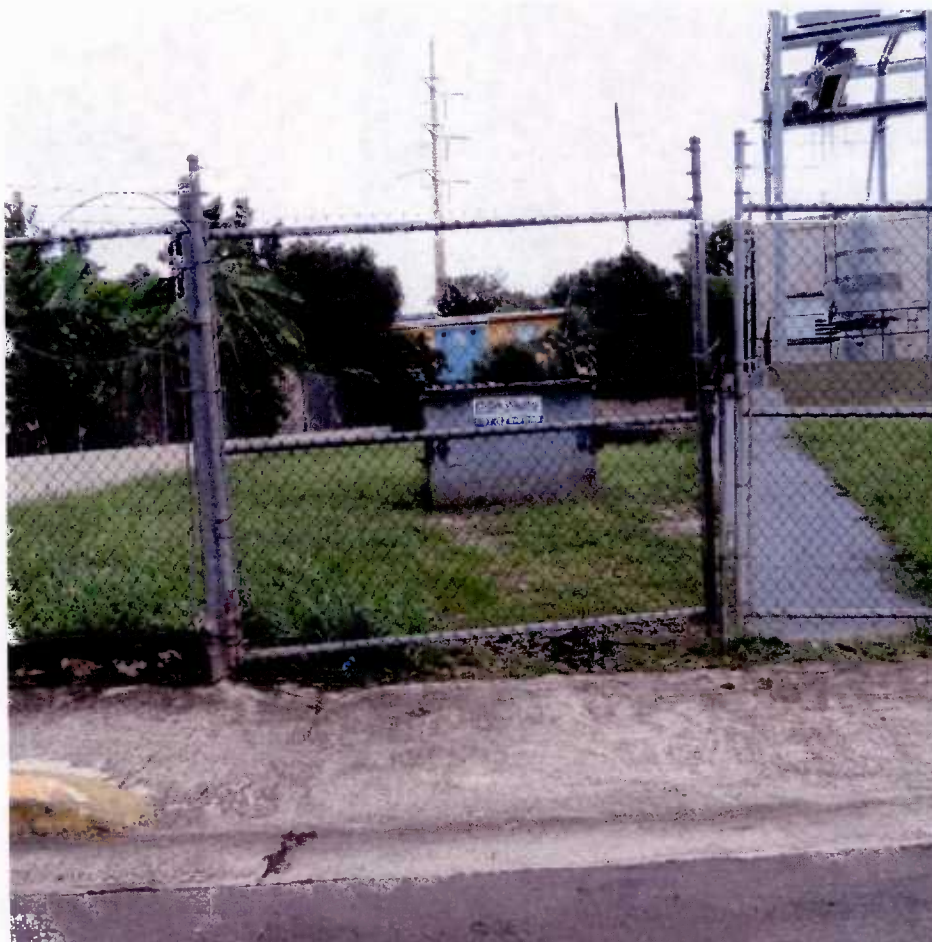
DSCN1370.JPG  
07/08/2013  
Nikon Coolpix P510

DSCN1370	Grass area at the Stop 18 Pump Station

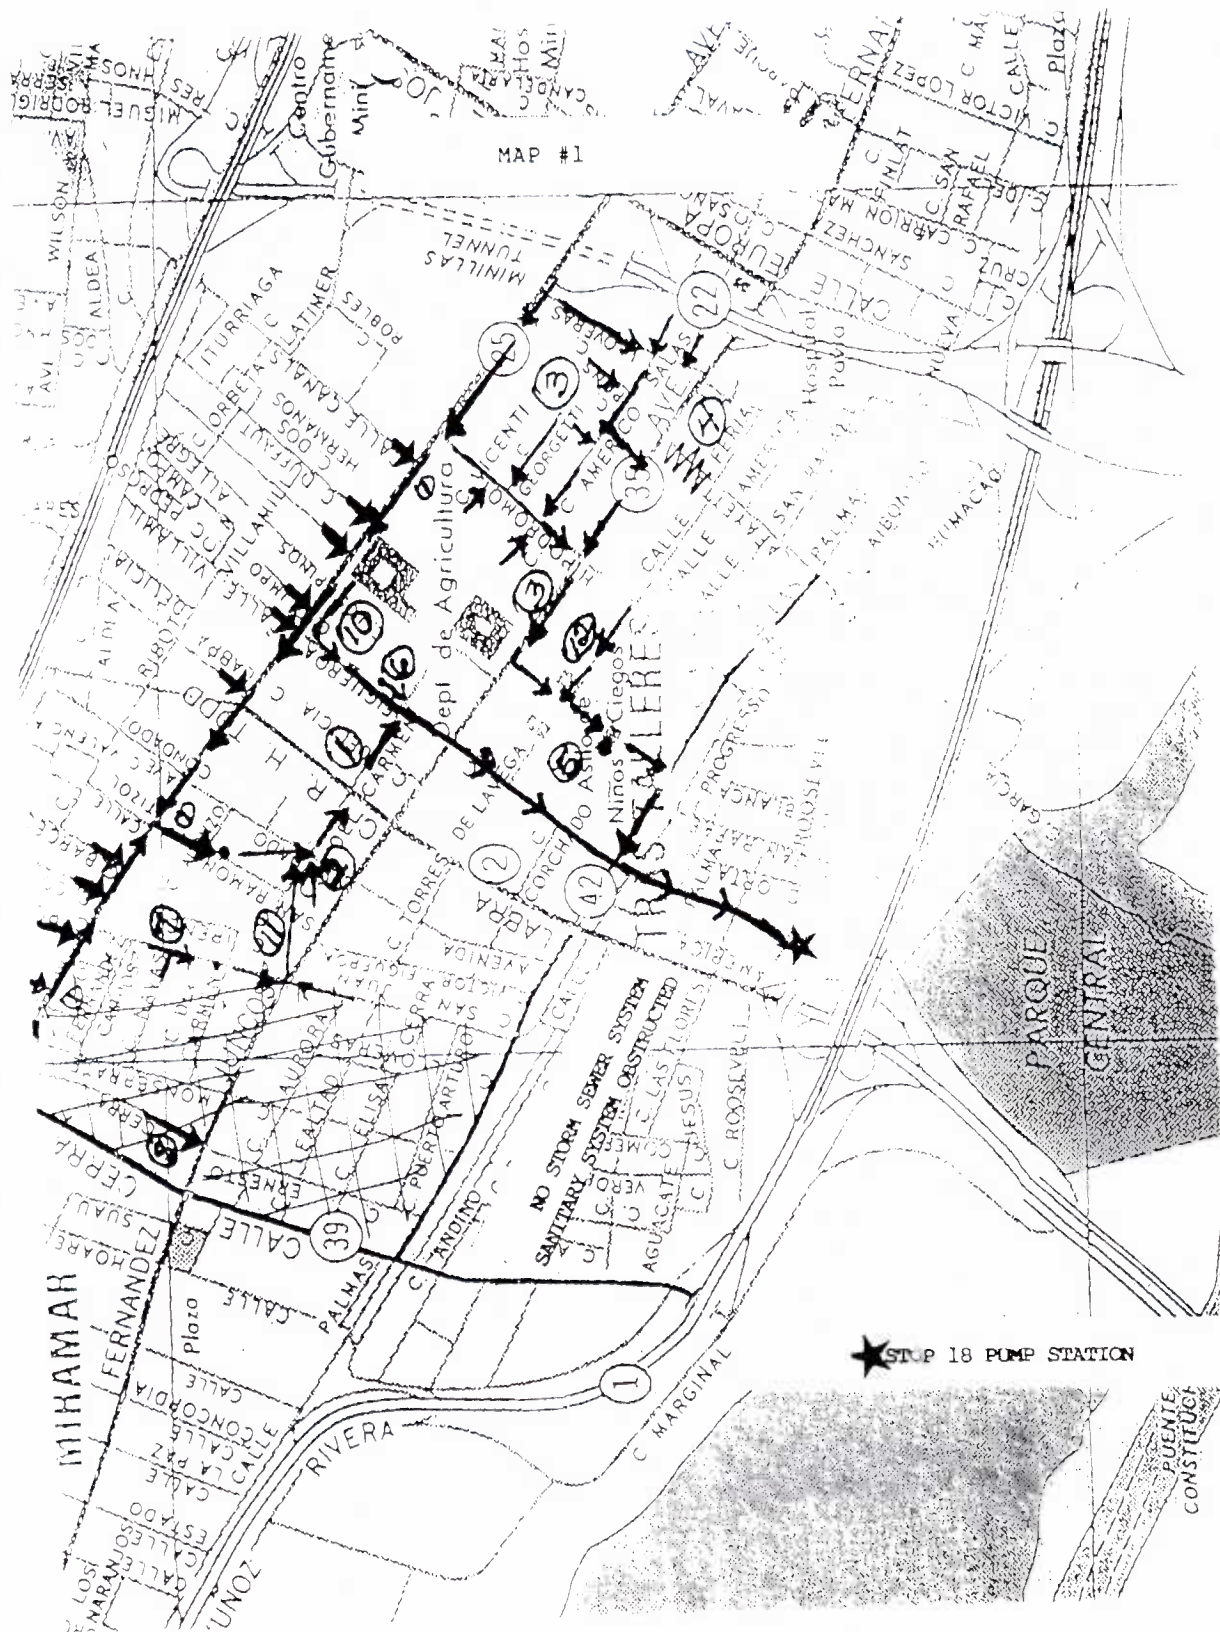
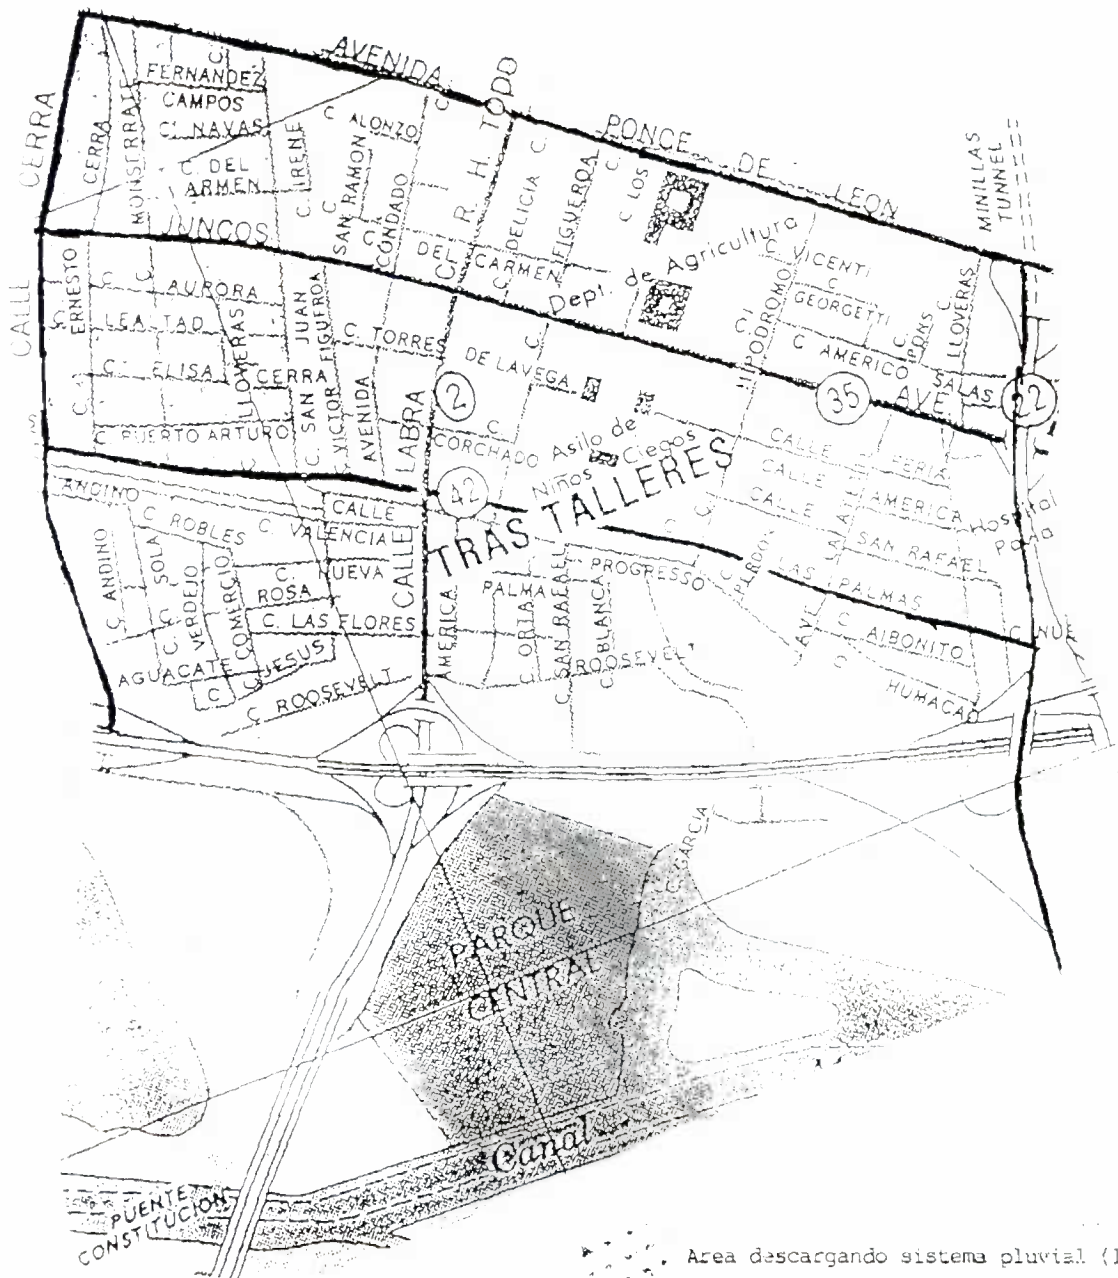
The investigation already performed by the Waterbodies Restoration Division of EQB's Water Quality Area shows there are several situations, almost all related with deficiencies in the sanitary systems of the Puerto Rico Aqueduct and Sewer Authority (PRASA), that are responsible for the wastewater discharges to the Stop 18 storm sewer pumping station and to the Martín Peña Canal. These deficiencies and the interconnections of wastewaters to the storm sewer system are contributing with more than half of the sanitary waters that are reaching this pumping station and are being discharged to the Martín Peña Canal. These situations are illustrated on Map #1 and are described as follows:

Each of the above situations are shown in Map #1. The situations described in #1,3,11 and 12 are the ones with the greatest amount of sanitary waters to the Stop 18 Pump Station. However, Map #3 shows several areas within the study area that are pending to determine the disposal and/or origin of the sanitary waters to storm sewers. The obstruction of the sanitary and storm sewer systems is the principal obstacle to such determination. The clean up of these storm and sanitary sewers have been requested in several occasions to PRASA and to the Municipality of San Juan in order to finish our investigations (See appendix I). This clean-up has not yet been done.
